# Service Bulletin

Bulletin No.: 06-02-35-002

**Subject:** Diagnostic Trouble Code (DTC) C0710 Steering Wheel Position Sensor (SWPS) Signal, Service Stability System Message on Driver Information Center (DIC) (Inspect and Secure Wires in SWPS Connector)

**Models:** 2004-2006 Cadillac XLR  
2005-2006 Chevrolet Corvette  
with Steering Wheel – Tilt, Telescoping (RPO N37)

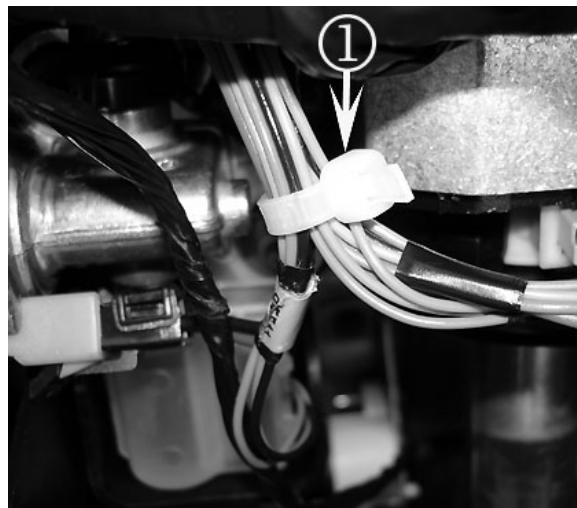
1714896

The most likely cause of a DTC C0710 on a vehicle equipped with telescoping/tilt steering wheel is high resistance in SWPS connector C202. Fretting terminal corrosion maybe present in the SWPS connector due to the telescoping motion of the steering column. When the steering column is telescoped in and out, the female terminals within the SWPS connector may move on the male terminals of the SWPS. This movement between the terminals may cause a high resistance condition in the SWPS connector.

1. Remove the driver's side close out panel.
  - Cadillac XLR — Refer to Closeout/Insulator Panel Replacement - Left (SI Document ID 1207847)
  - Chevrolet Corvette — Refer to Closeout/Insulator Panel Replacement - Instrument Panel (I/P) Lower (SI Document ID 1495116)
2. On XLR models only, locate and remove the plastic strap (1) on the steering column harness that retains the three wiring harnesses. Discard this strap.
3. Disconnect the SWPS connector C202 located on the lower center of the steering column.
