Service Bulletin

Bulletin No.: 06-02-35-002B

Subject: Stabilitrak/Active Handling Light On, Service Stabilitrak/Active Handling

Models: 2008 Buick Lucerne

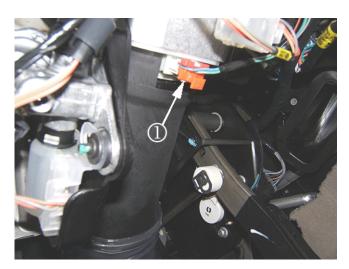
2030089

The most likely cause of a DTC C0710 on a vehicle equipped with telescoping/tilt steering wheel is high resistance in SWPS connector C202. Fretting terminal corrosion may be present in the SWPS connector due to the telescoping motion of the steering column. When the steering column is telescoped in and out, the female terminals within the SWPS connector may move on the male terminals of the SWPS. This movement between the terminals may cause a high resistance condition in the SWPS connector.

- 1. Remove the driver's side closeout (insulator) panel.
- 2. Locate the SWPS connector that connects to the steering angle sensor, located on the lower center of the steering column.

- 3. Install the clip (1), P/N 19179794, into the connector. This clip will act as a terminal positive assurance (TPA) and prevent any movement of the terminals.
- 4. Reinstall the closeout panel.
- 5. Clear the DTC with a scan tool and road test the vehicle.
- 6. If DTC C0710 resets during the road test, refer to DTC C0710 in SI.
